The lost Mars Lander: What we think we know about the Mars Polar Lander

Rob Manning
JPL Chief Engineer
JPL/Caltech/NASA

March 4, 2018
IEEE Aerospace Conference

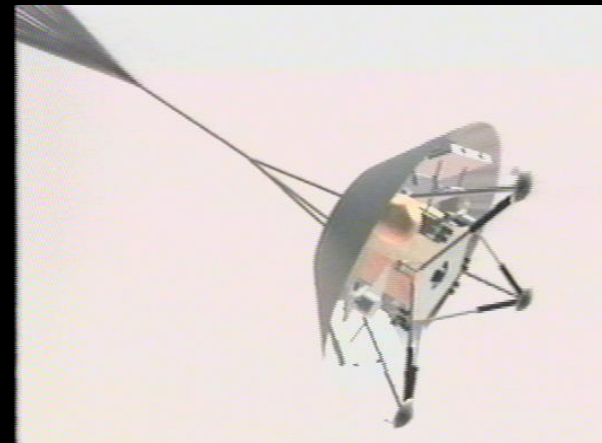
Official Most Probable Cause

"Premature shutdown of descent engines"

A flight software (FSW) error was discovered 2 months after landing that would have likely have shut down the engines prematurely.

- FSW continuously monitored a Hall effect sensor in each of the legs.
 - If it sees a detection, it makes a note of it
- The sensor pulsed during leg deployment while under the chute. many km above the ground.
- In preparation for landing, at 40 m above the ground engine shutdown was enabled.
- The FSW looked to see if the hall effect sensors had tripped. They had.
- The odds where good that the lander would have fallen 40 m and hit Mars at 50 MPH (22 m/s)

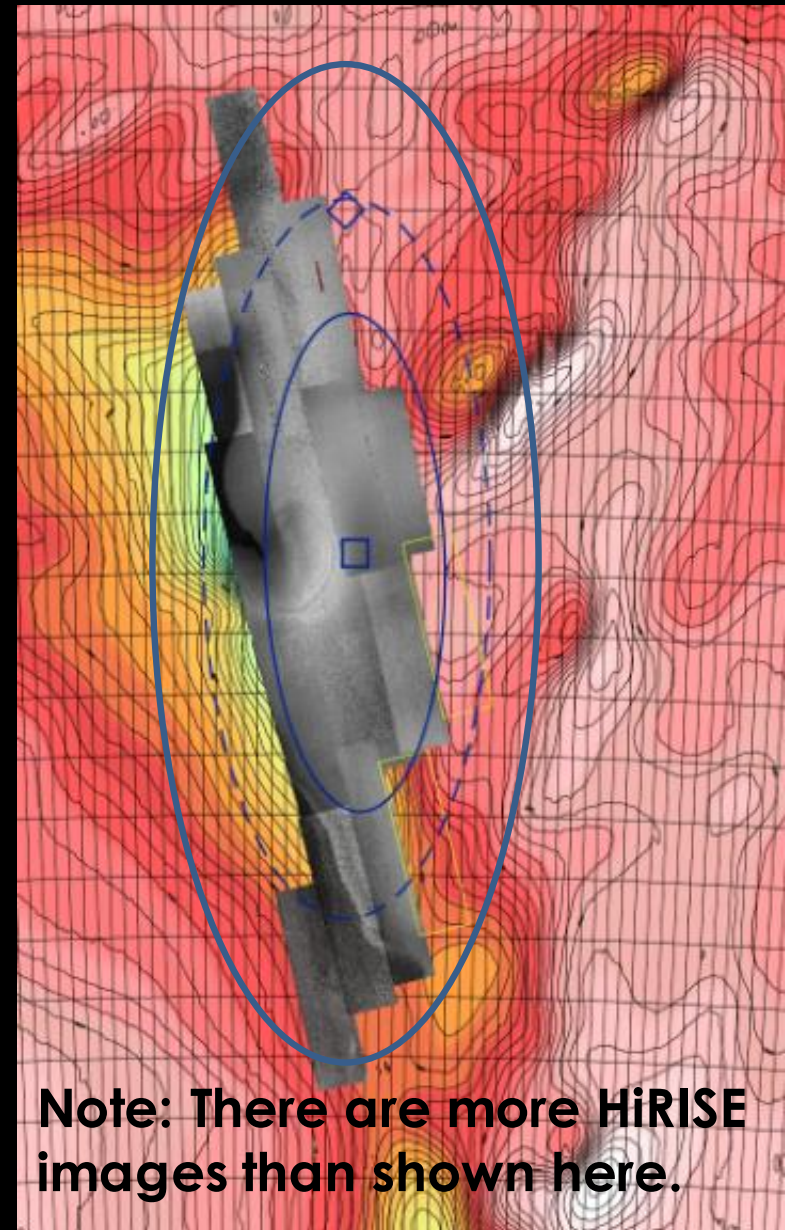
MRO HiRISE Search for MPL

- HiRISE has found Beagle II, cruise stages, rovers, and many more human-made objects on Mars.
- By now, all of the 1-sigma and most of the 2-Sigma (>80%) of the reconstructed MPL landing area has been covered by <1m resolution HiRISE images.
- Not even a glint has been seen.
- We would expect at least a backshell and parachute, if not a lander.
- Where is it?

Note: There are more HiRISE images than shown here.

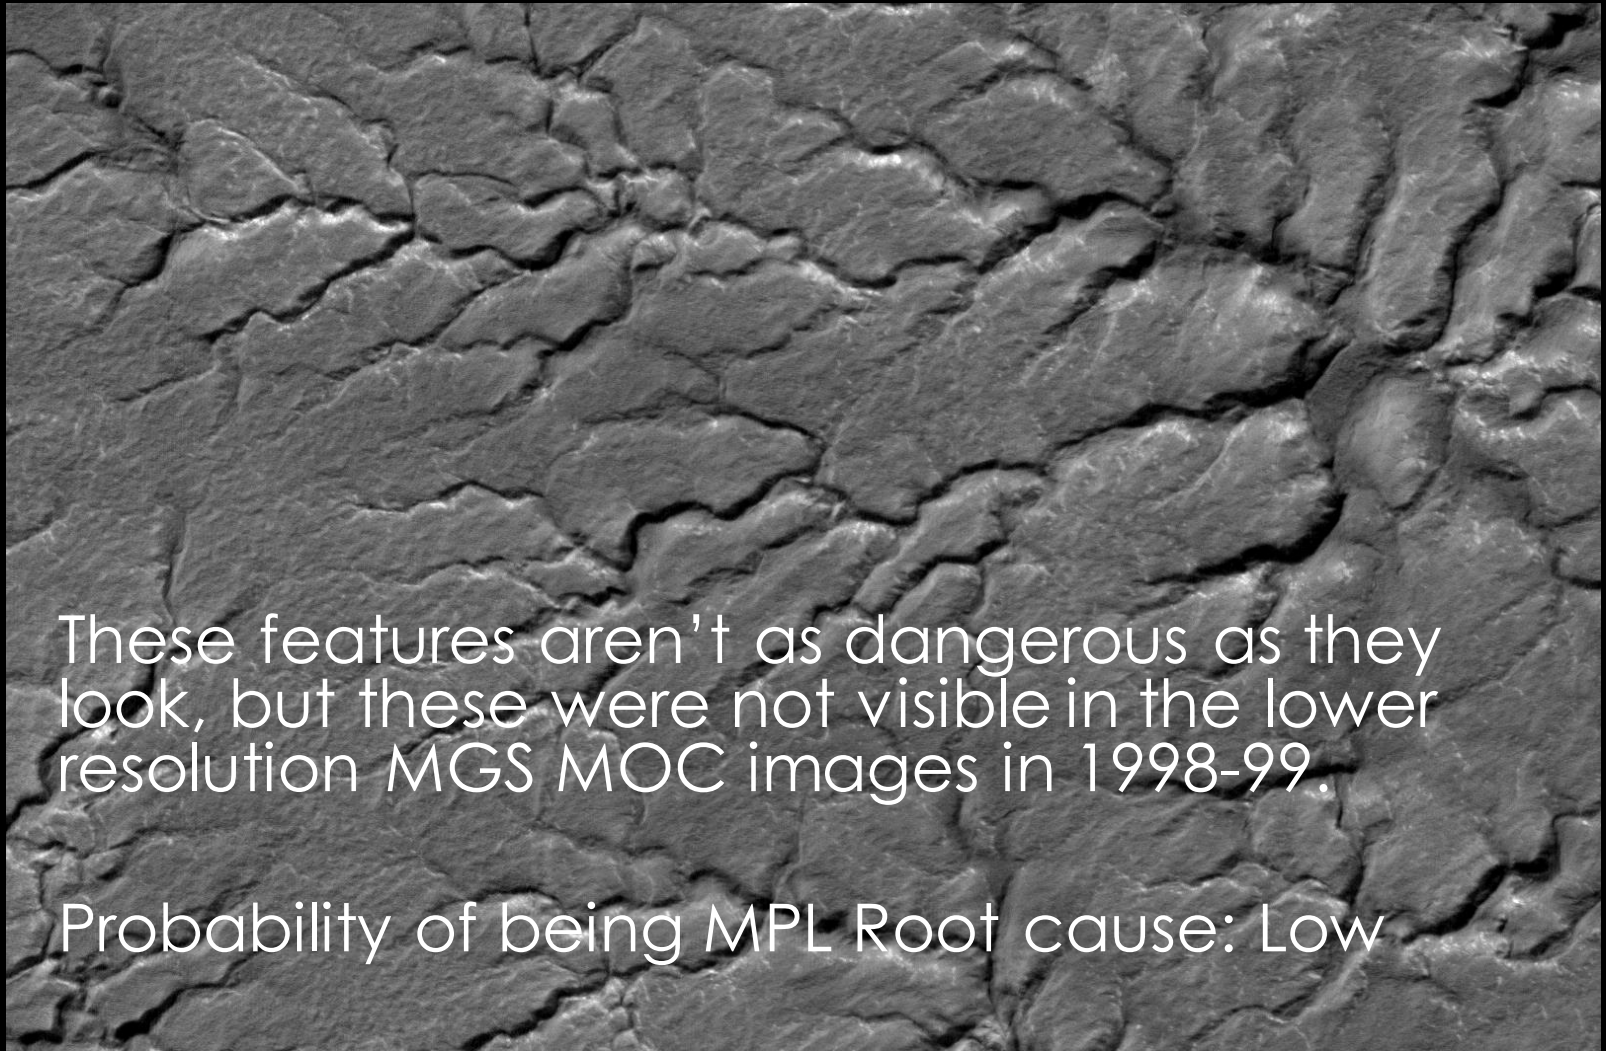
1. Landed in unexpected meter-deep
spidery gullies" in ellipse resulting in
tip-over.

These features aren't as dangerous as they
look, but these were not visible in the lower
resolution MGS MOC images in 1998-99.

Probability of being MPL Root cause: Low

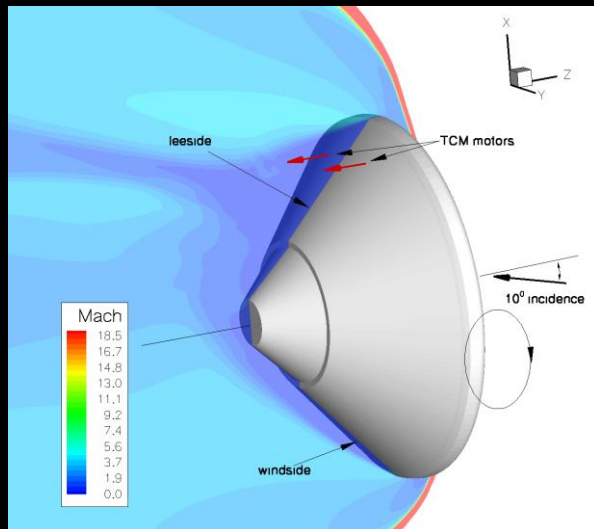
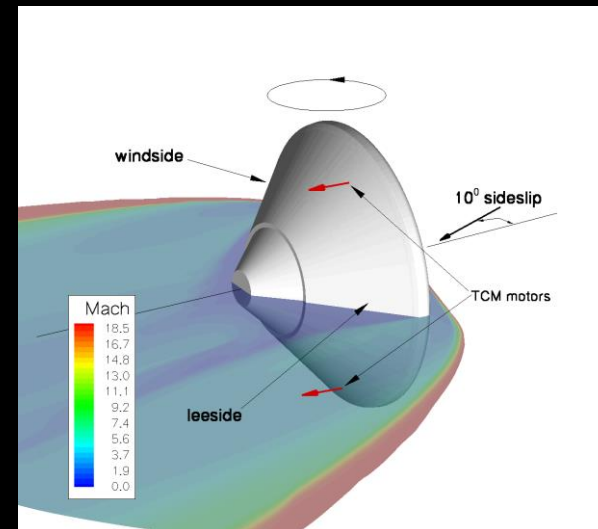
9. RCS-aero thrust reversal could lead to loss of attitude control and tumbling in late entry before parachute deployment

- While performing RCS thruster plume steady state CFD analysis, the PHX team discovered that there could be large uncertainty in both *magnitude and sign* of the induced moments on the yaw RCS thrusters used for 3-axis control during entry.
- Control inversion would have resulted in dynamic instabilities and possibly tumbling.
 - Especially sensitive in the pre-parachute deploy supersonic regime

Probability of being MPL Root cause: Medium

- PHX decided to effectively “turned off” RCS during entry (after using the RCS to perform the turn to the entry attitude).
- It was felt to be safer if the vehicle simply flew into Mars as a passive “knuckle ball”.
 - The first ever. (It worked!)
 - Same for InSight.
-

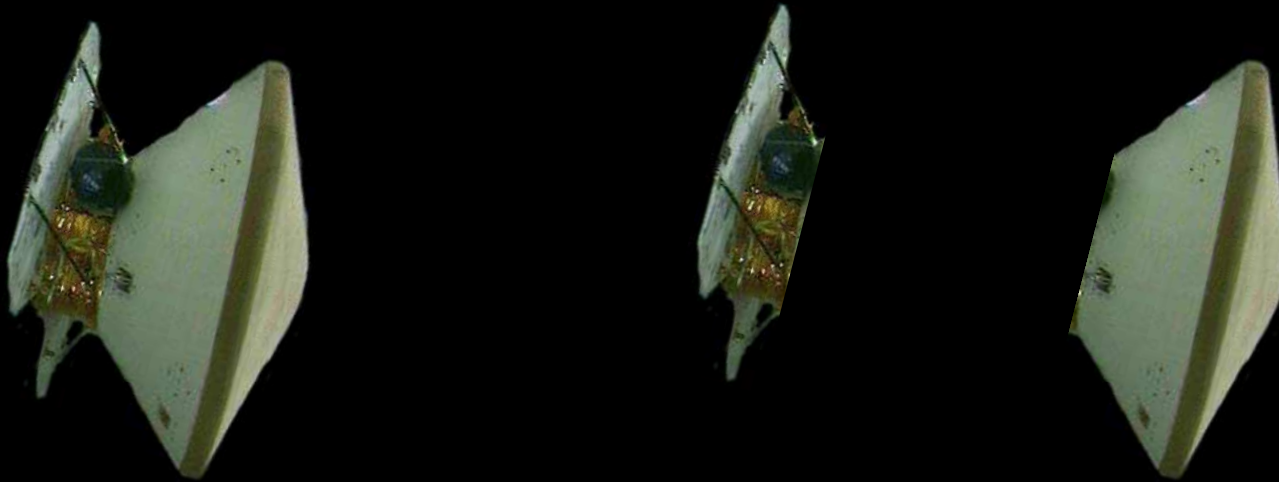
10. Cruise stage breakup and recontact with the entry vehicle leads to damage, dynamics and/or destruction

- Cruise stage pushes off springs to separate from entry vehicle (from behind) 5 min before start of entry.
- Initially having lower a ballistic number than the entry vehicle causes it to get further behind the entry vehicle.

- New “burn up and breakup codes” developed after the Colombia loss allowed the PHX team to delve into this more deeply.
- The team learned that in 100 s, the cruise stage solar arrays melt off, leaving much higher ballistic coefficient cruise stage hardware to speed up (including the launch vehicle adapter ring).
- These large pieces would “catch up” and pass the entry vehicle less than 6 meters away.
 - Leading components could have impacted HS.

Probability of being MPL Root cause: Medium

- In retrospect we learned that this phenomena would have also threatened Mars Pathfinder and MER (Spirit and Opportunity) during those landings.
- Did we get lucky?
- PHX (& MSL) changed Cruise stage orientation out of plane.
 - Cruise stage allowed to break up off to one side of the entry vehicle's trajectory.

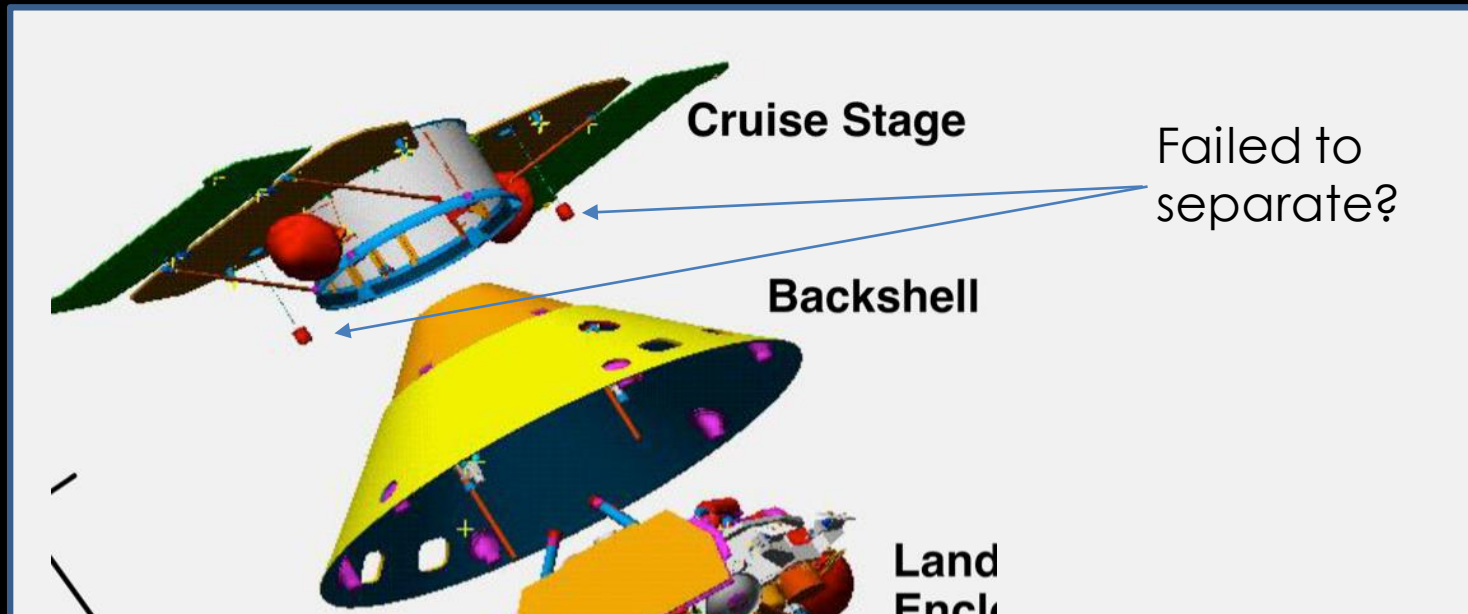
11. Cruise stage separation connectors hang leading to tumbling and loss of Vehicle (and the two DS-2 microprobes)

- There were two lanyard-pull electrical separation connectors between the cruise stage and the entry vehicle (on the entry vehicle).

- Pull testing at the flight temperature of -75C required more than 100 lb of force. PHX discovered that these connectors were not designed to separate at -75 C.
- This would have led to complex multibody dynamics and uncertain aerodynamics and excessive aeroheating and possible breakup.
 - Connectors may have eventually released due to backshell heating.
- PHX added connector heaters

Probability of being MPL Root cause: Medium High
